Manhole Inspection Summary

Manhole # S31S1_022MH

Location Address: **801 Reedbird Ave. (in the woods)** Cross Street: **Cherryland Rd.**

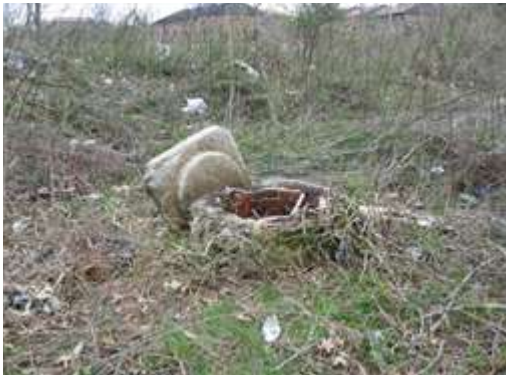
Location View

In the woods south of Reedbird Ave.

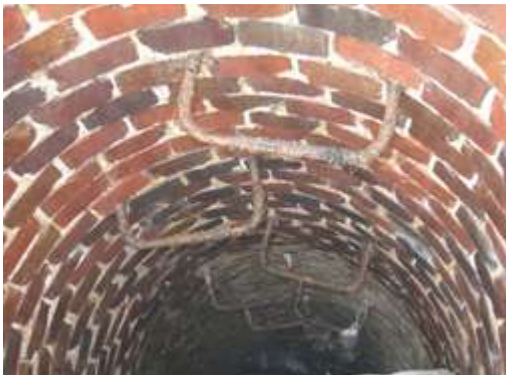
Steps Count: **12** Missing: **0** ☒ **Corroded**

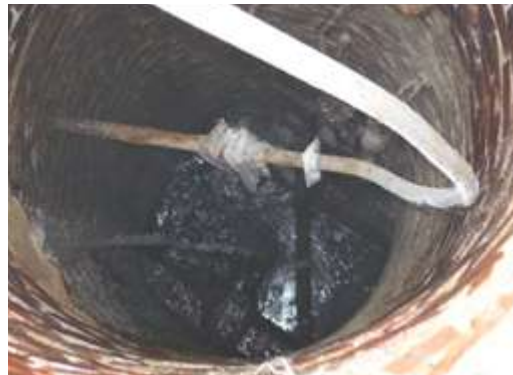
Defect 1

Large poles in manhole

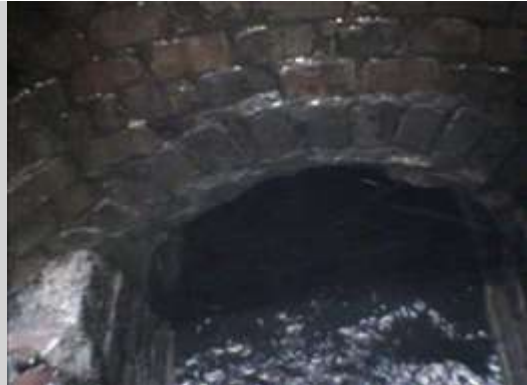
12 O'Clock Outflow

Pipe Height: **27.6** (in.) Rod and Bar (Angled)
Pipe Material: **Clay** ☐ Pipe Lined
Invert Depth: **20.65** (ft.) Flow Characteristics: **Fast**
Deposits: ☒ None ☐ Mud ☐ Sludge ☐ Debris ☐ Grease
Silt Depth: (in.) Deposits Extent:
Infiltration: **None** Pipe Seal Cond: **Sound**

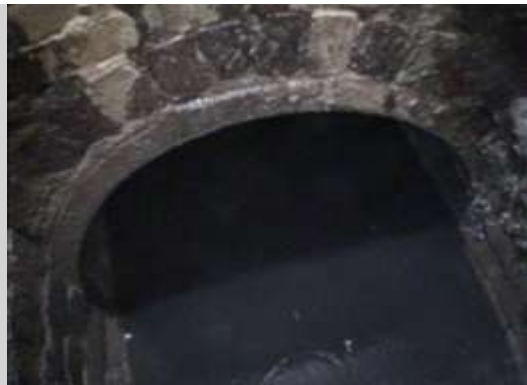
6 O'Clock Inflow

Pipe Height: **27.6** (in.) Rod and Bar (Angled)
Pipe Material: **Clay** ☐ Pipe Lined
Invert Depth: **20.57** (ft.) Flow Characteristics: **Fast**
Deposits: ☒ None ☐ Mud ☐ Sludge ☐ Debris ☐ Grease
Silt Depth: (in.) Deposits Extent:
Infiltration: **None** Pipe Seal Cond: **Sound**

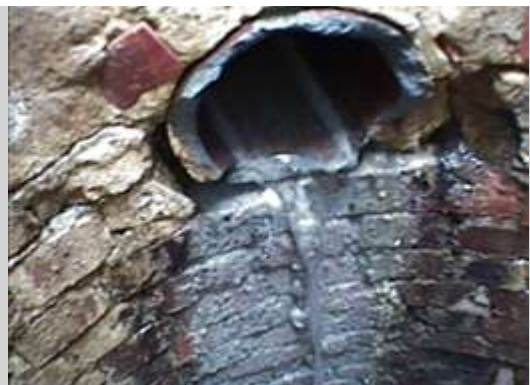
9 O'Clock Inflow

Infiltration: **None** Pipe Seal Cond: **Broken**

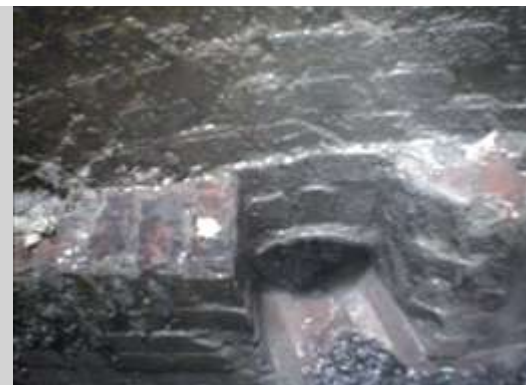
Drop In @ 9 O'Clock

Drop: **Outside** Rod and Bar

Drop Condition: **Open**
